Manhole Inspection Summary

Manhole # S29YY1006MH

Location Address: **501 COTSWOLD RD** Cross Street: **AMBERLY AVE**

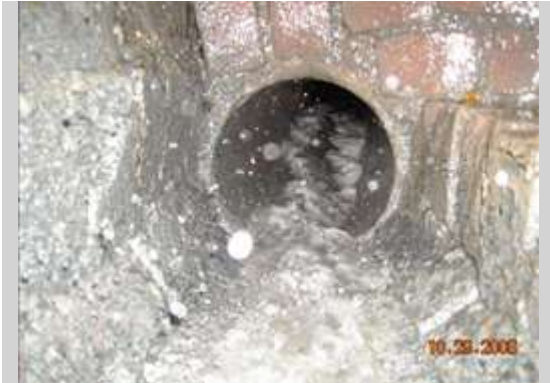
8 in. Circular Gravity Sewer Pipe Out @ 12 O'Clock

Invert Depth: **17.55** (ft.) Flow Characteristics: **Fast**

Deposits: ☒ None ☐ Mud ☐ Sludge ☐ Debris ☐ Grease

Infiltration: **None** Pipe Seal Cond: **Unknown**

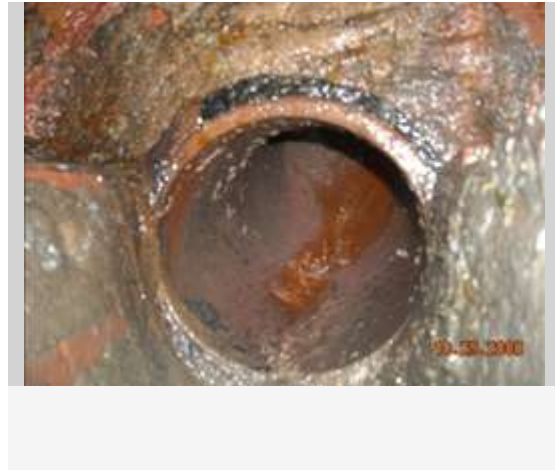
Drop In @ 9 O'Clock

Infiltration: **None** Pipe Seal Cond: **Roots**

Drop: Outside	Rod and Bar
Angled: Yes	Reading: 15.71 (ft.)
	Inv Depth: 16.71 (ft.)
Drop Condition: Open
